Demonstration of FRP Composites for the Repair and Maintenance of Navigation Gates and Structures

2014 Locks Maintenance Workshop
Smyrna, TN

Richard Lampo
Materials Engineer
ERDC / CERL, Champaign, IL
11 February 2014

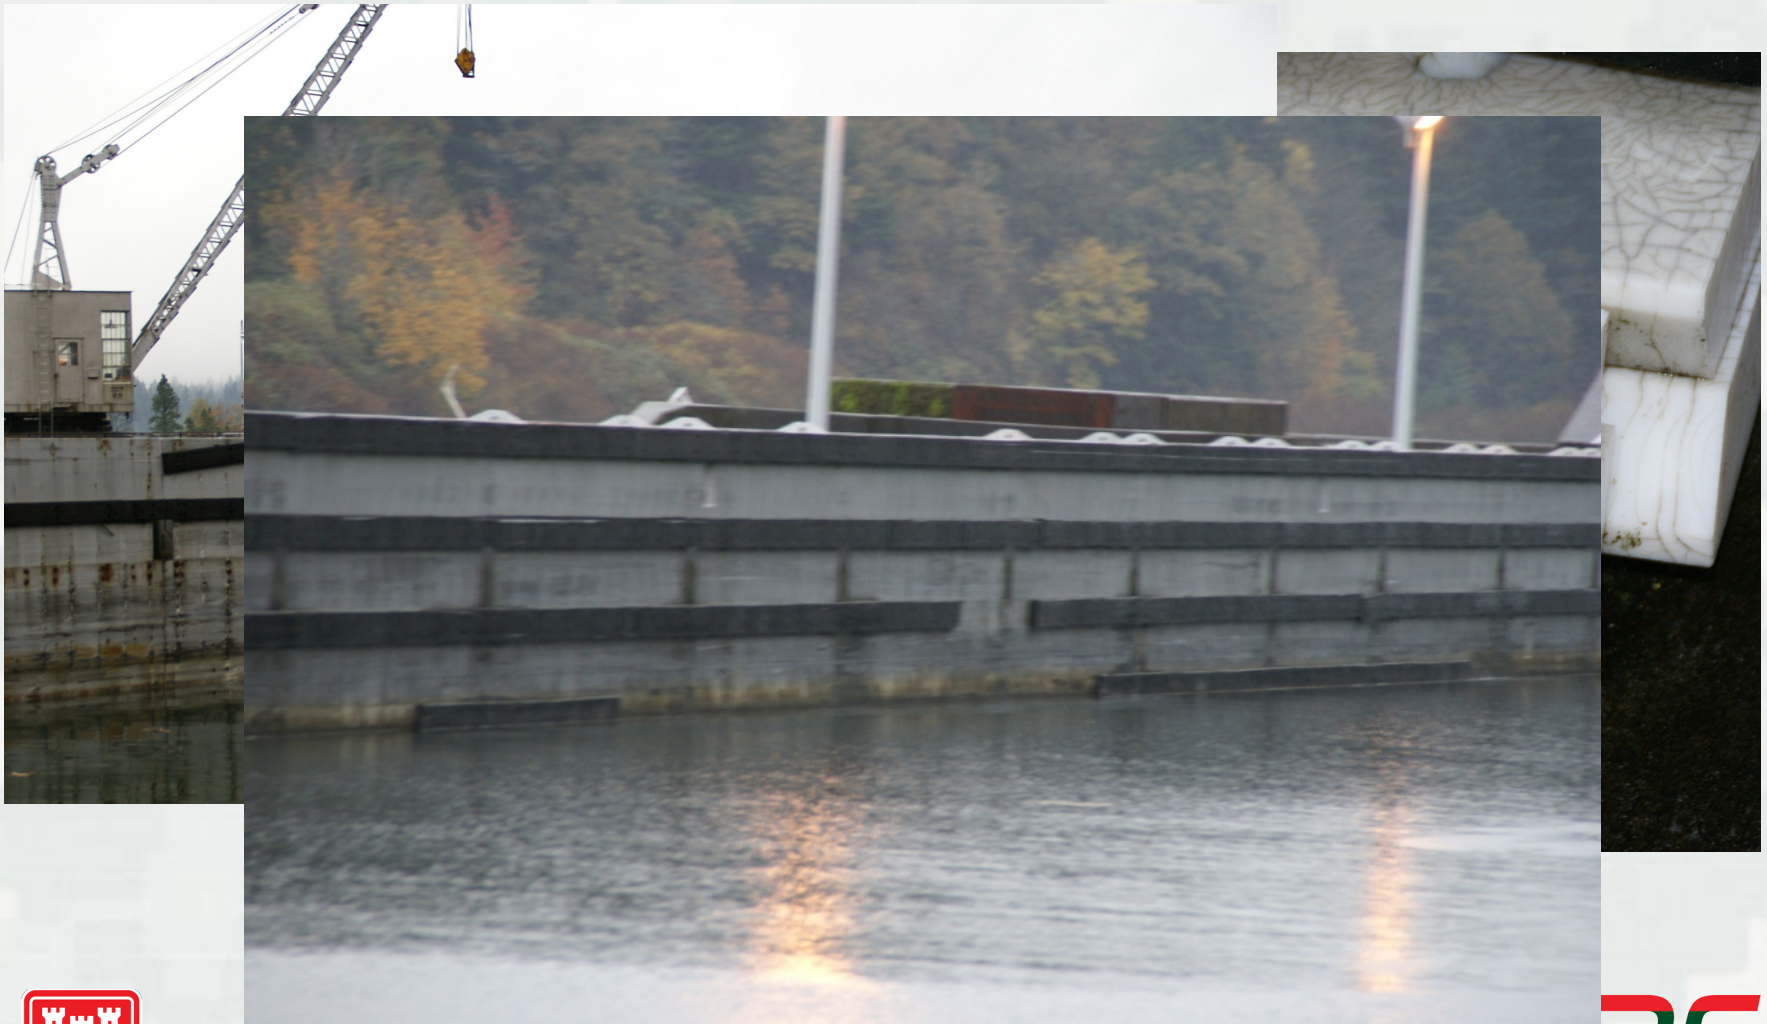
- UHMW-PE Rub Blocks – Bonneville Dam, OR

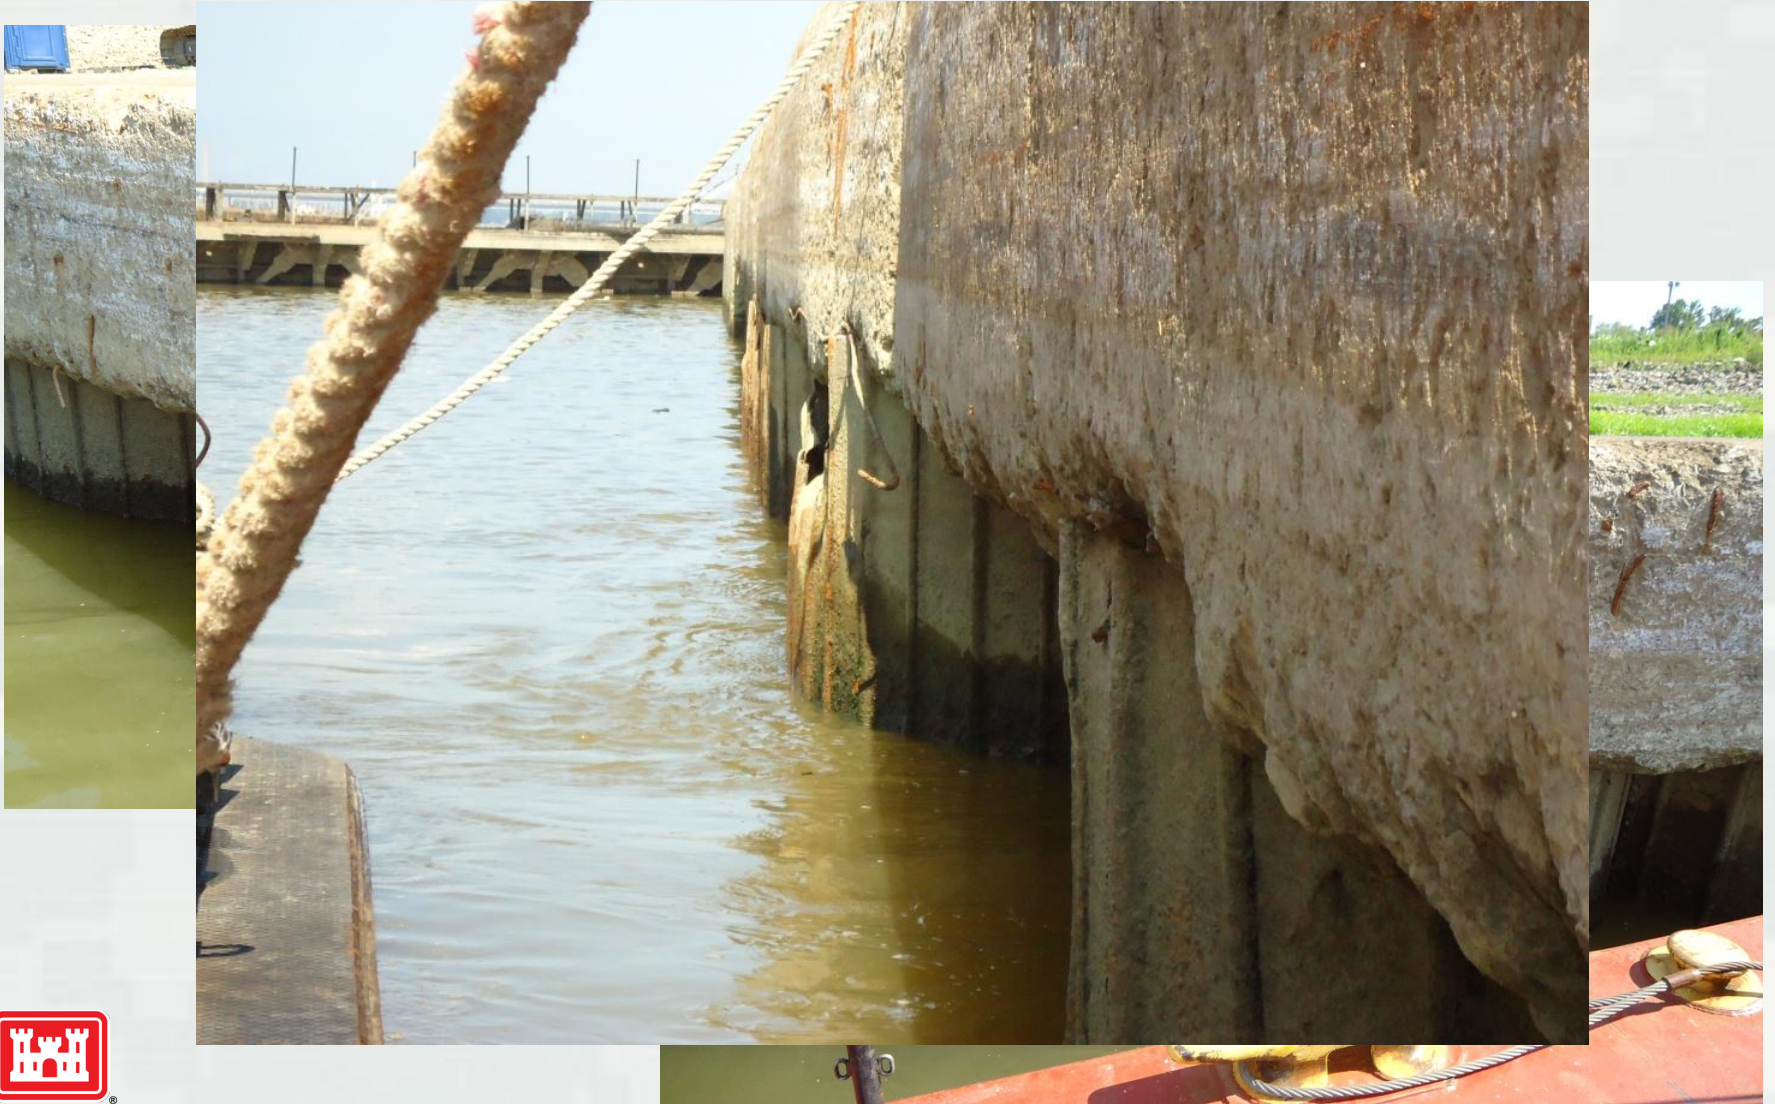
- Wall Armor Needed L&D #52 – considering UHMW-PE sheets

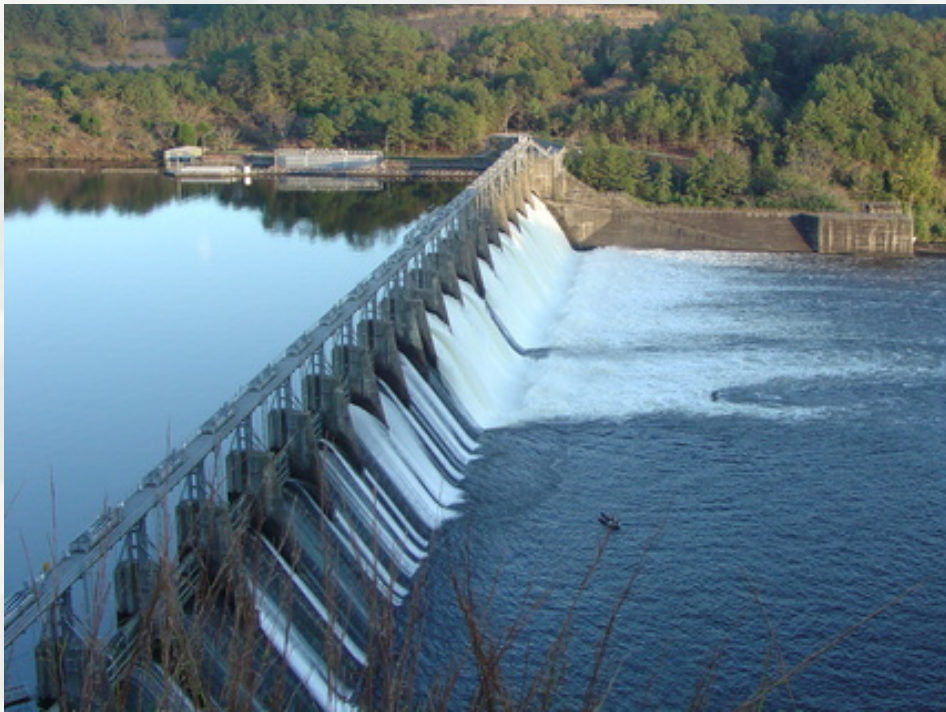
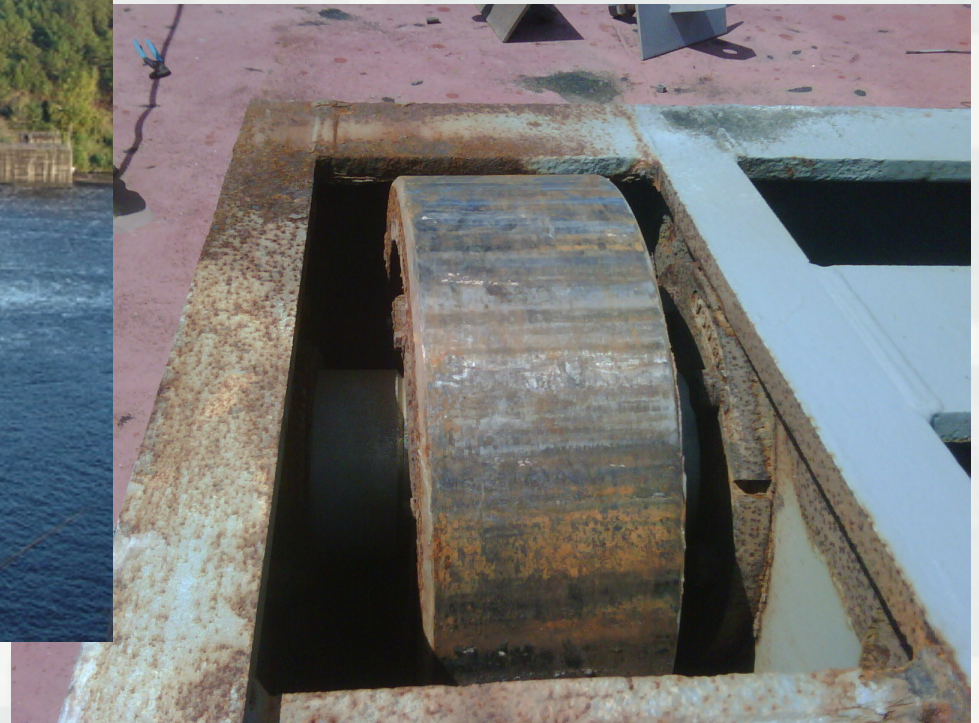
- **Replace Frozen Rollers on Lift Gates at Bankhead Lock & Dam in AL.** The reaction rollers cease up due to corrosion and drag when gate is raised or lowered. Design a repair using polymer composite glides with no moving parts.

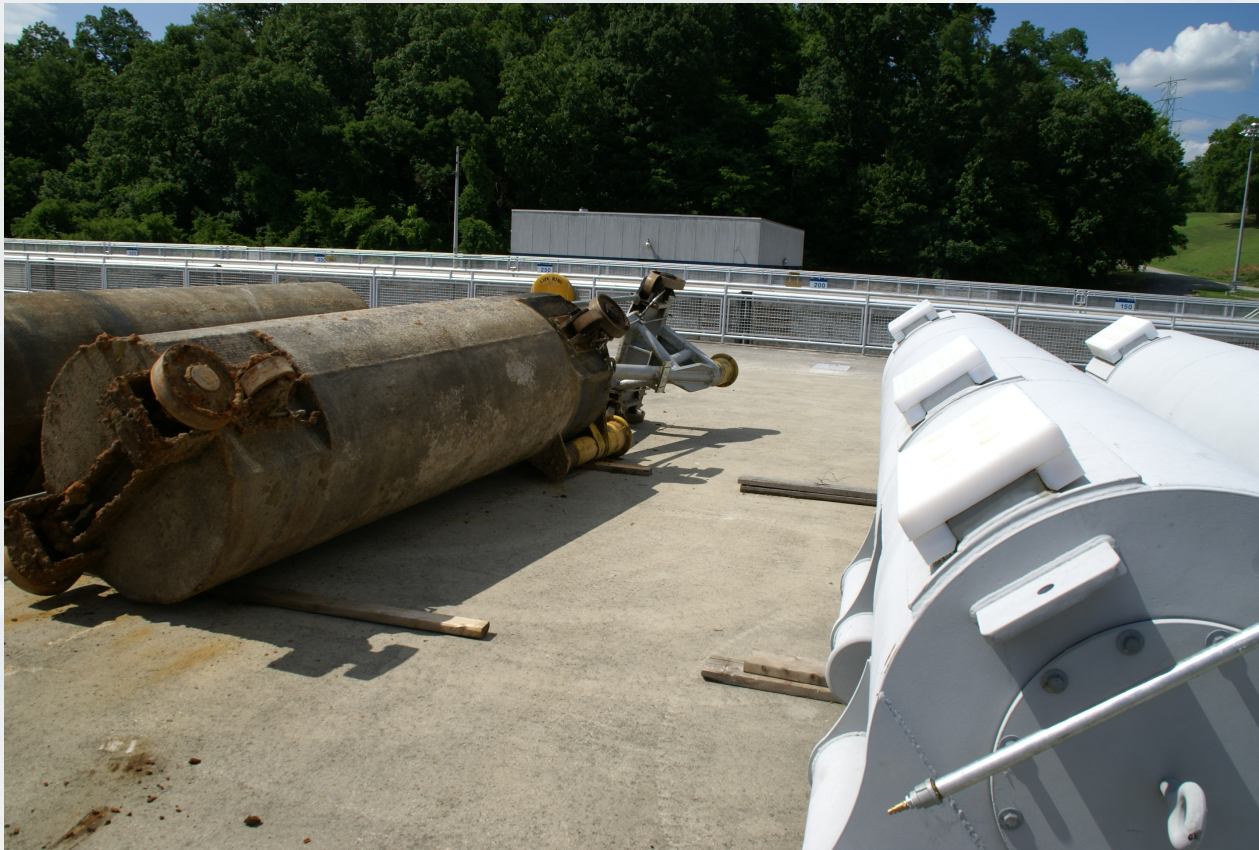
Replacing wheels on floating mooring bits with polymer slides.

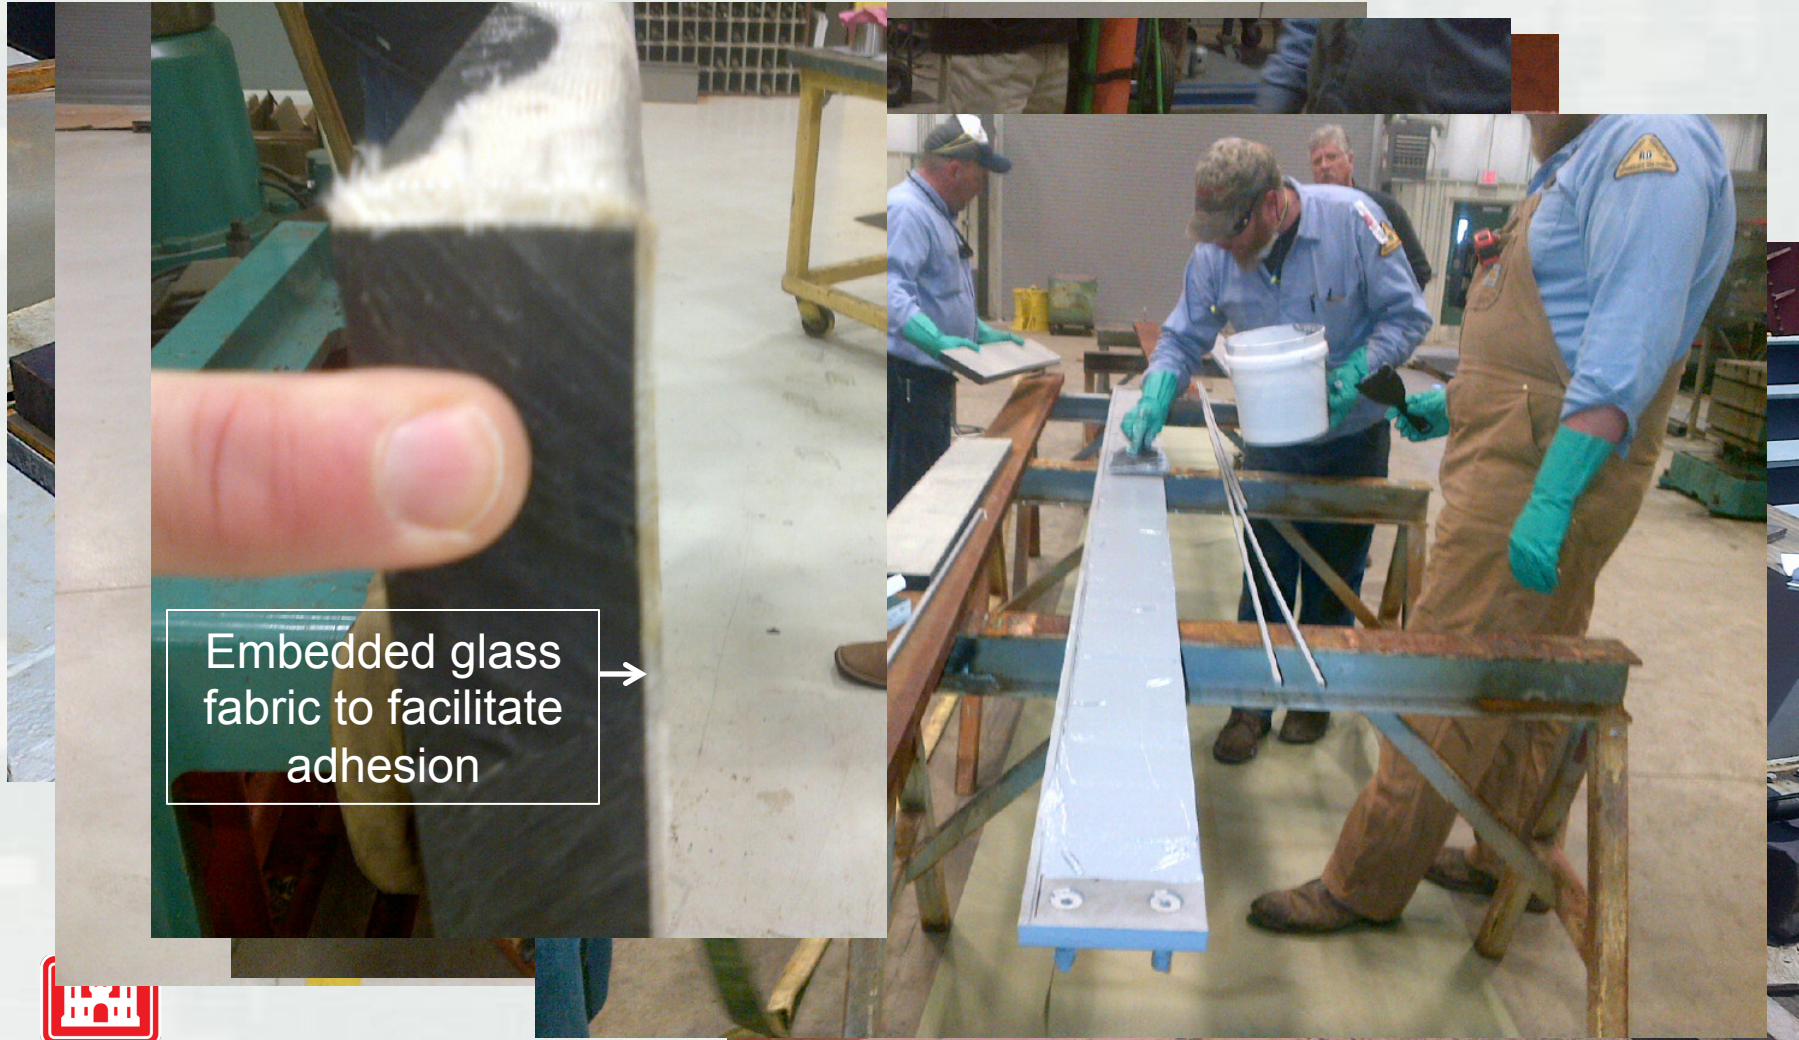
Adhesively applied UHMW-PE for Slides

(Instead of mechanical fastening)

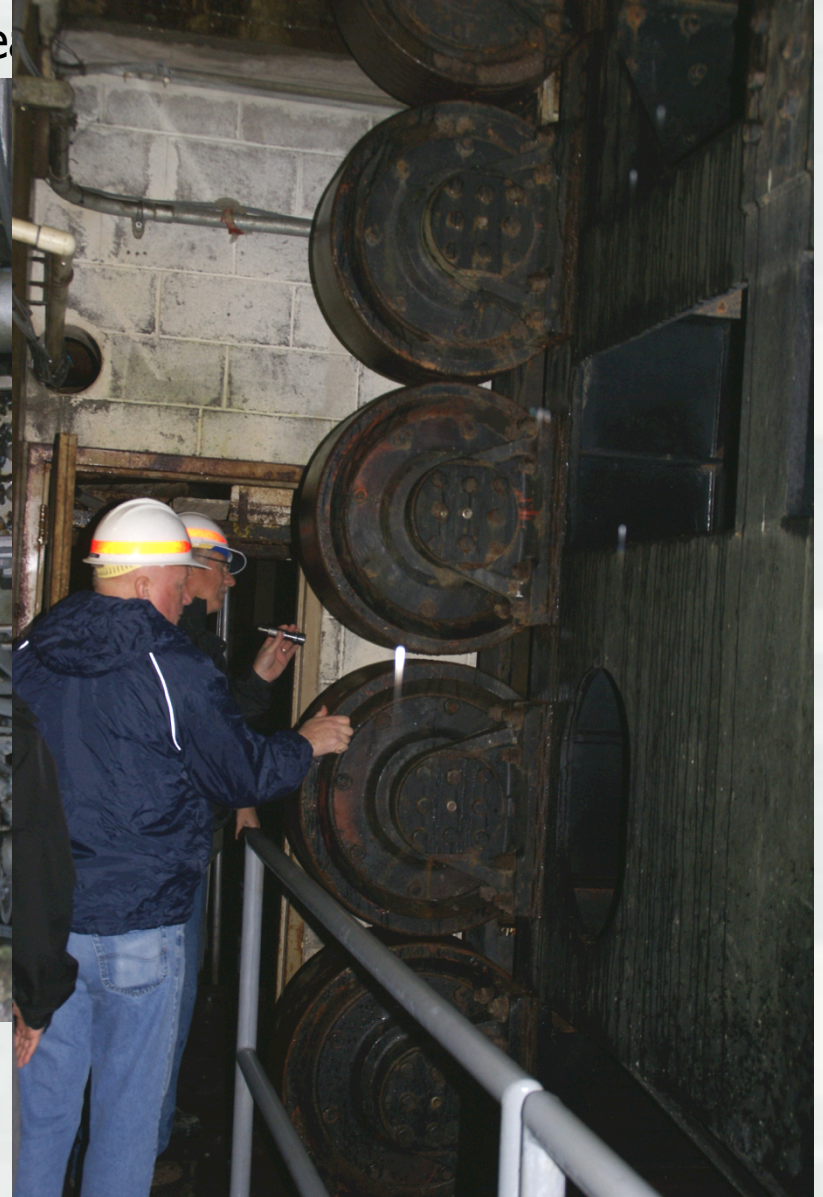
Reimbursable – Replace Rollers on Lift Gates at Bonneville Dam

Taller gates, higher head than at Bankhe

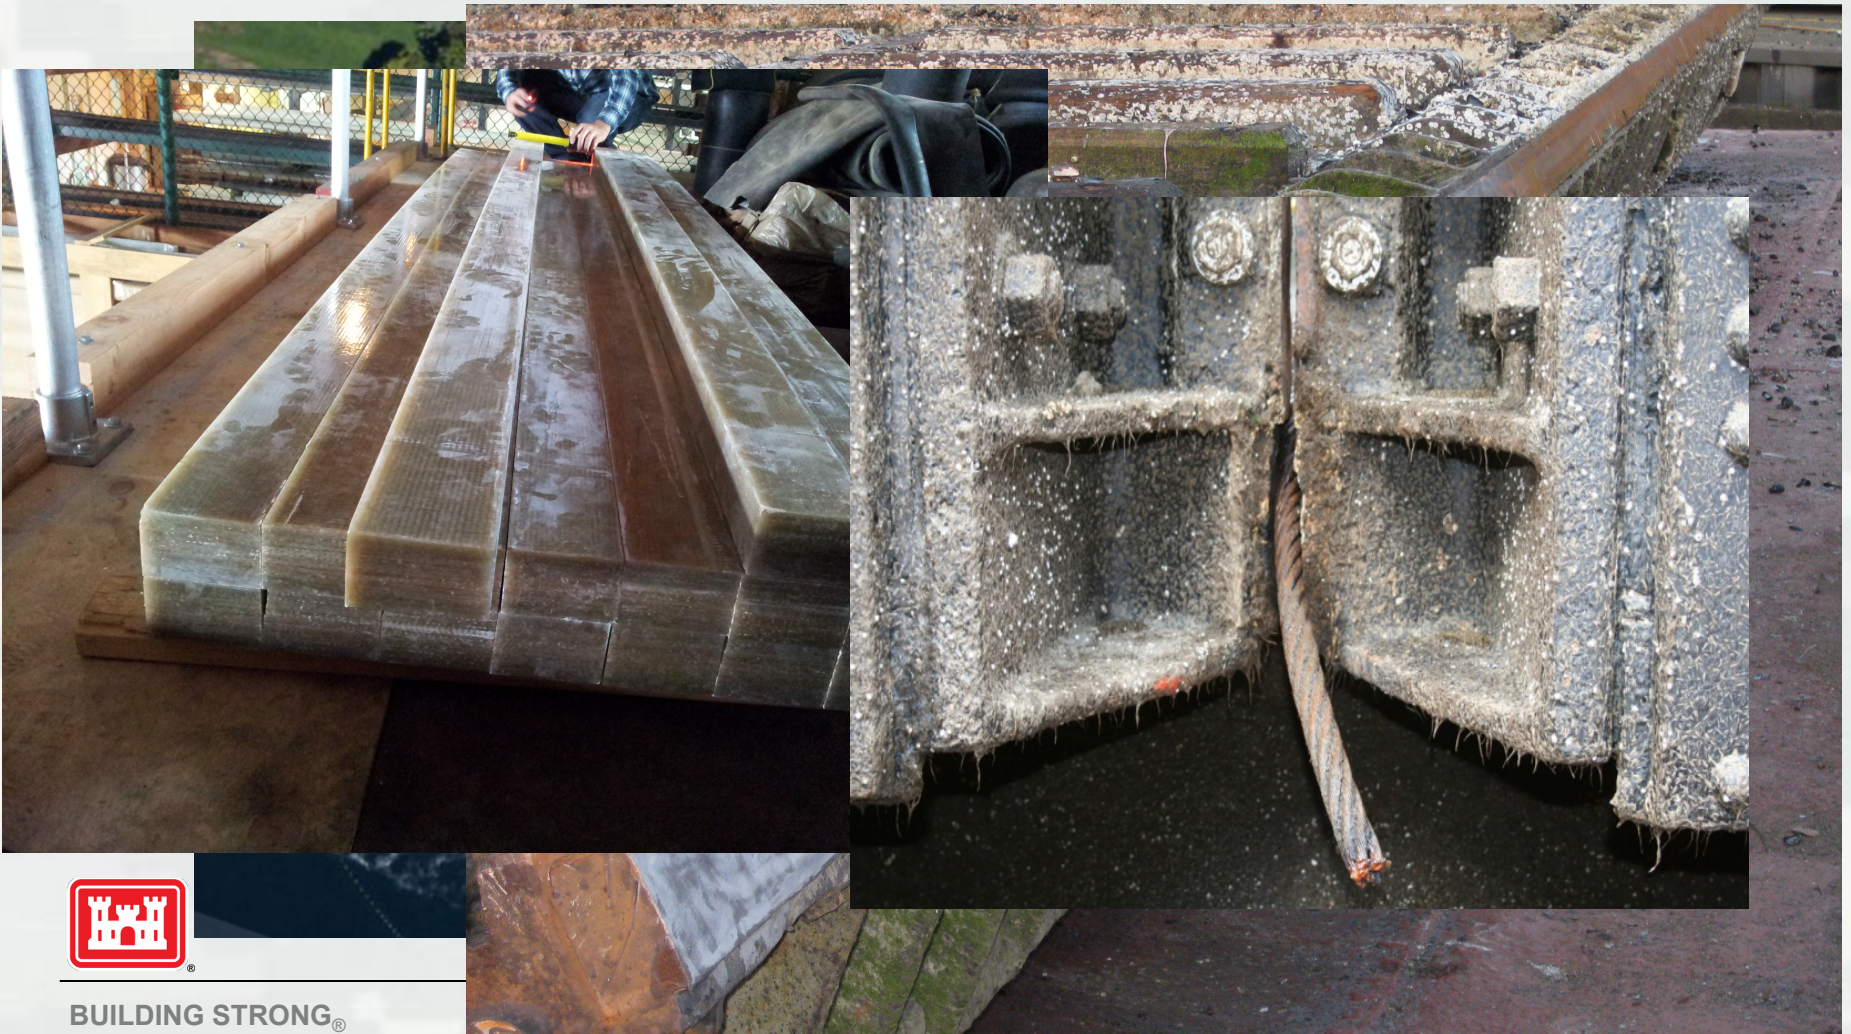
- **FRP Composite Miter Blocks for small lock on Washington Lake Canal, WA.** Blocks are 39 feet long on upper service gate and 19 feet long on lower service gate.

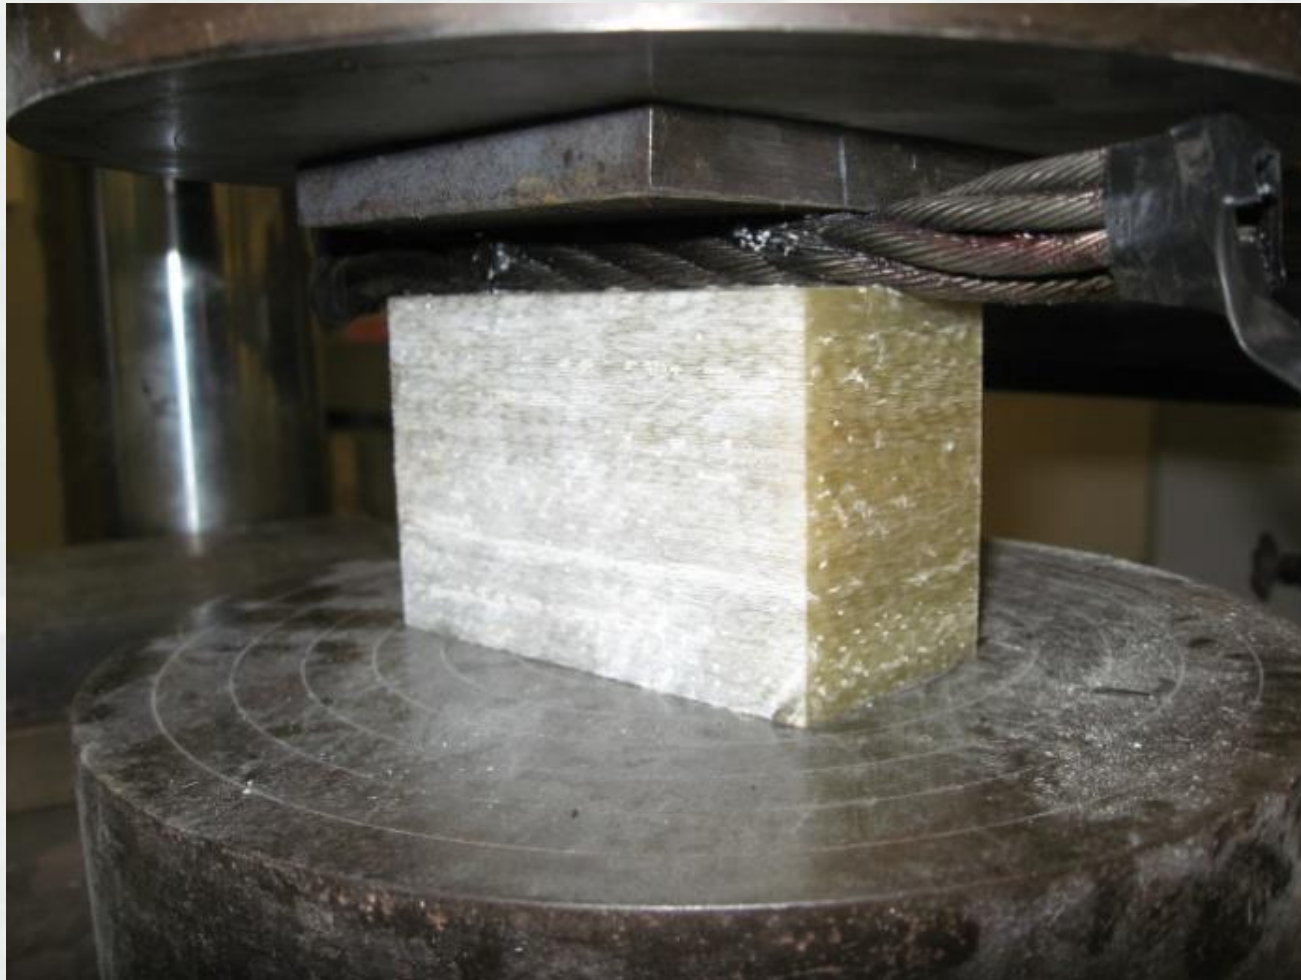
Behavior When Pinching Foreign Object

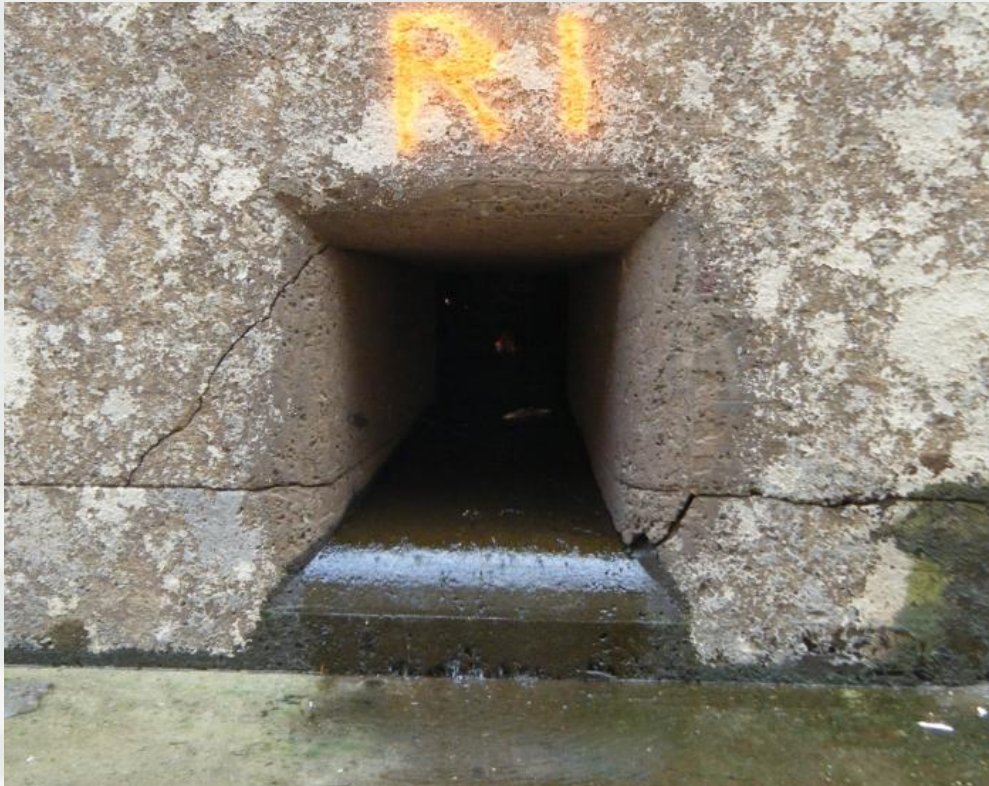
Example cracking at exit ports.

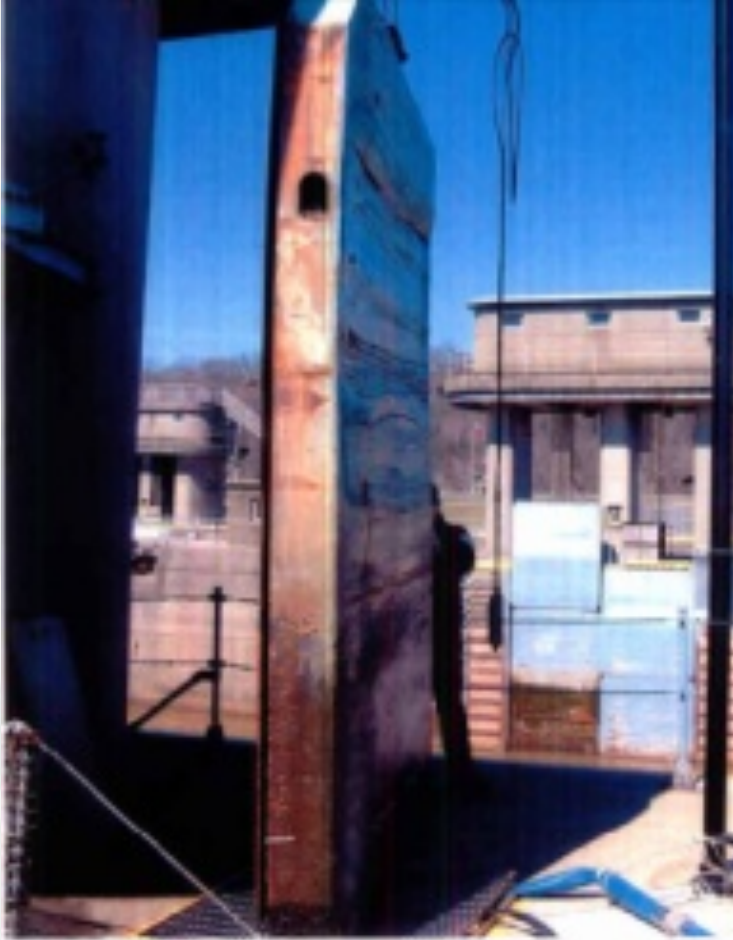
Current steel panels

- **Recess Filler Panels at Willow Island Locks and Dam, Ohio.** Steel panels costly, heavy, and they corrode.

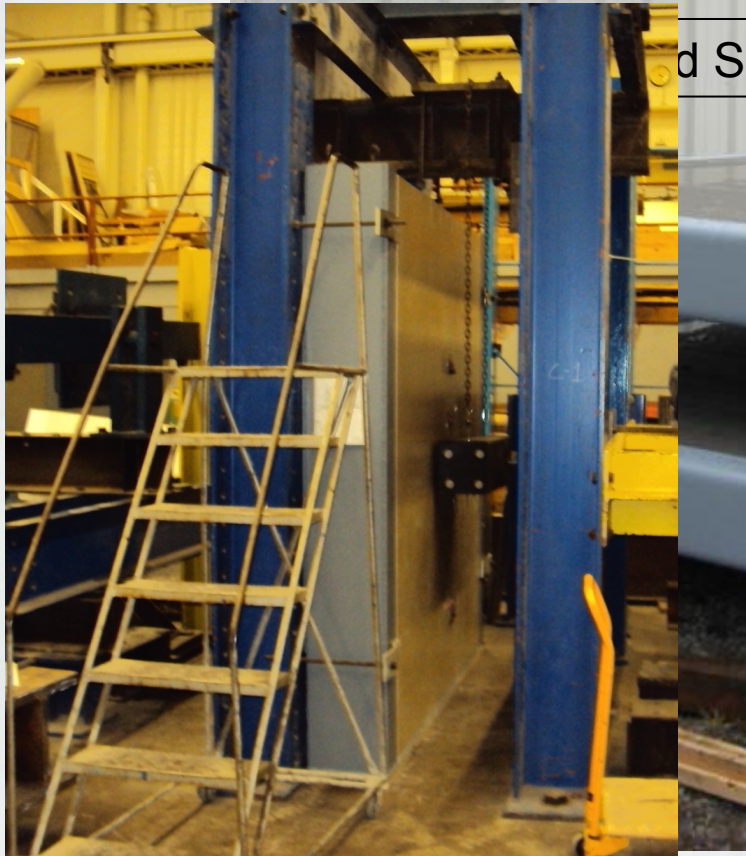
Lab testing

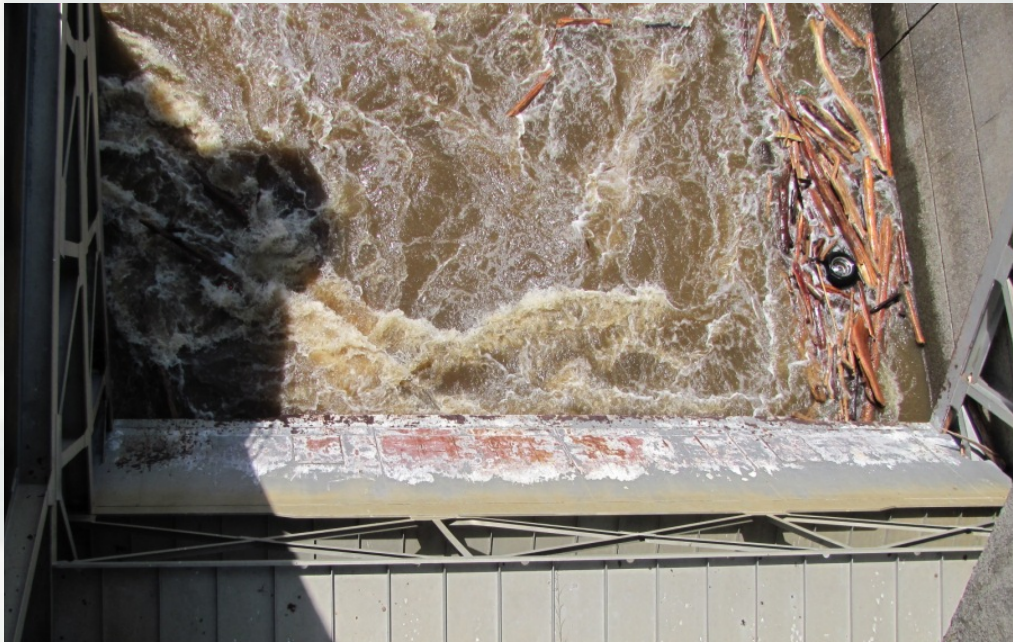
- **Abrasion - Resistant Overlays for Tainter Gates at Heflin Dam, AL.**
Swirling debris quickly damages traditionally used vinyl coatings.

Use organic and ceramic composites for overlays

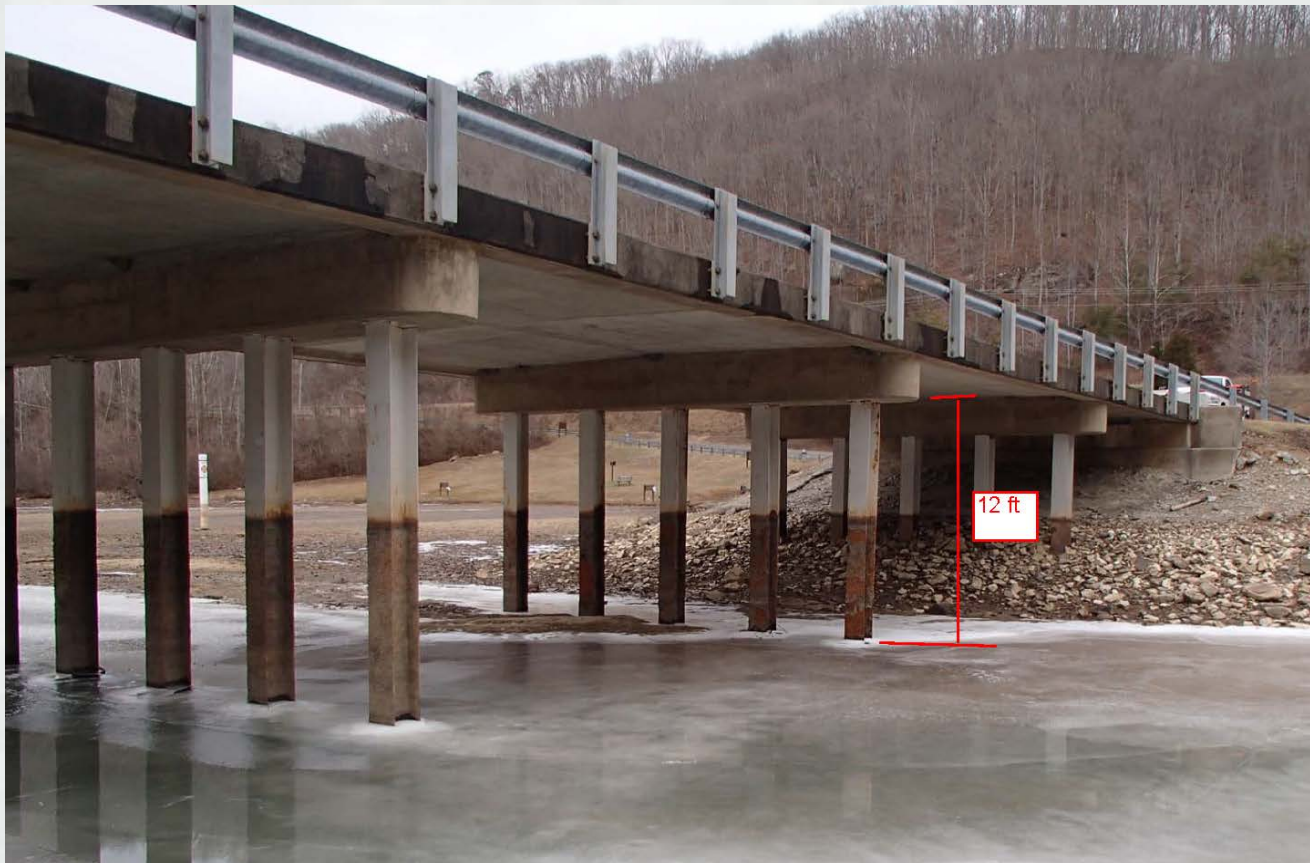
Bring load capacity back to original at 25% of cost using traditional methods. Use composite shell, wrapped, and then filled with grout. Funding for rehab from Huntington District and FHWA; Nav Sys supporting R&D activities associated with rehab.

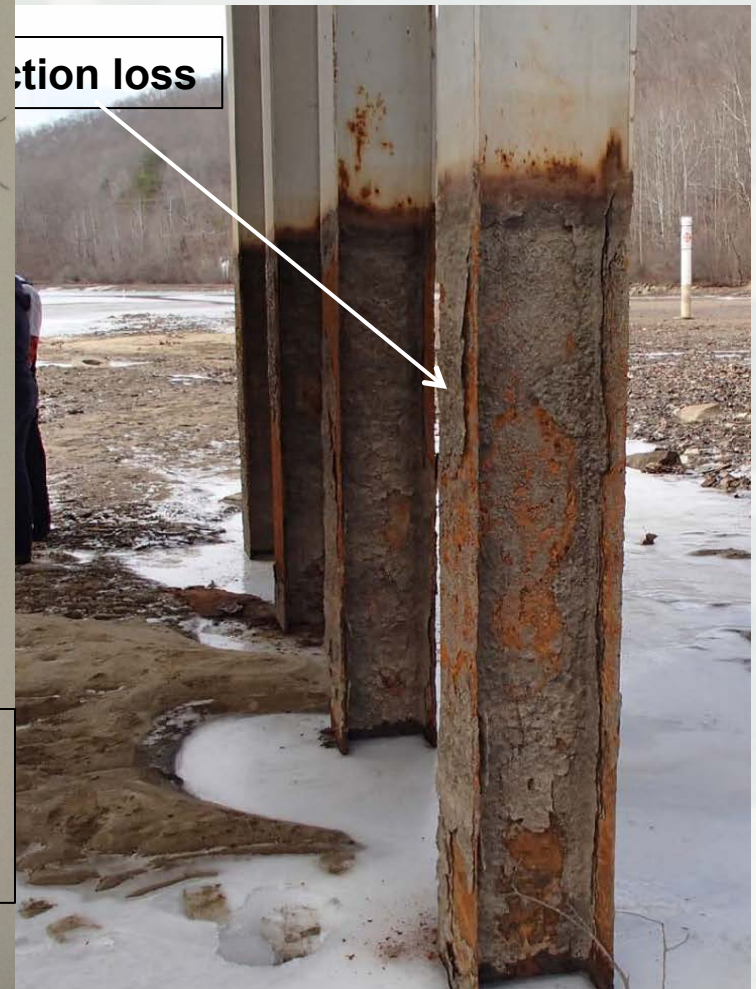
Section loss

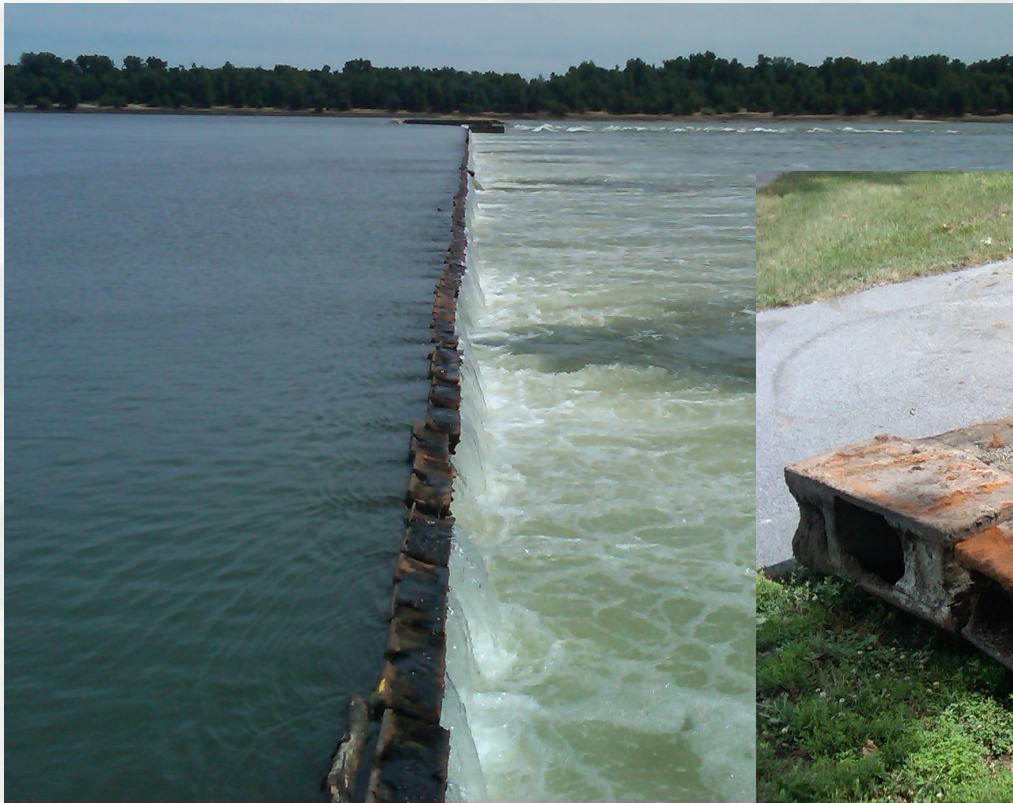
Traditional wooden wickets

FRP Composite Wicket Gates. Timber wicket gates: rapid deterioration, costly to replace. Stepping stone to future design and application of other larger FRP composite gates and valves. Prototype gates will be developed using both thermoset and thermoplastic composites. To be installed at L&D #52.
